DEPARTMENT OF TRANSPORTATION

Quality Assurance and Source Inspection

Contract #: 04-0120F4Cty: SF/ALA Rte: 80 PM: 13.2/13.9File #: 69.28**WELDING INSPECTION REPORT****Resident Engineer:**Siegenthaler, Peter**Address:** 333 Burma Road**City:** Oakland, CA 94607**Report No:** WIR-018793**Date Inspected:** 21-Dec-2010**Project Name:** SAS Superstructure**OSM Arrival Time:** 1500**Prime Contractor:** American Bridge/Fluor Enterprises, a JV**OSM Departure Time:** 300**Contractor:** Zhenhua Port Machinery Company, Ltd (ZPMC), Changxing Island **Location:** ShangHai, China**CWI Name:** Tian Lei**CWI Present:** Yes No**Inspected CWI report:** Yes No N/A**Rod Oven in Use:** Yes No N/A**Electrode to specification:** Yes No N/A**Weld Procedures Followed:** Yes No N/A**Qualified Welders:** Yes No N/A**Verified Joint Fit-up:** Yes No N/A**Approved Drawings:** Yes No N/A**Approved WPS:** Yes No N/A**Delayed / Cancelled:** Yes No N/A**Bridge No:** 34-0006**Component:** OBG**Summary of Items Observed:**

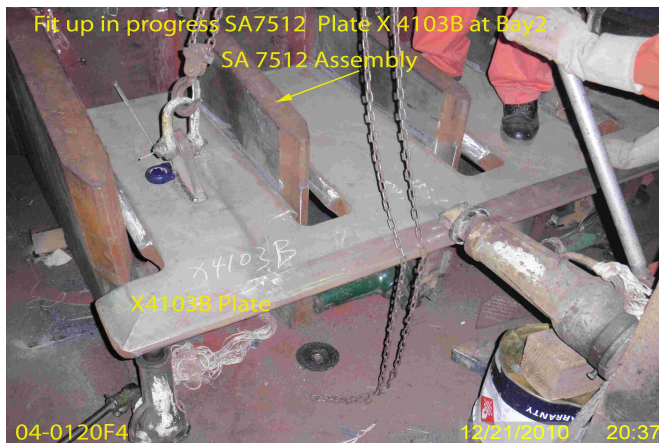
This QA inspector performed Visual Inspection (VT) of approximately 100 % of the area previously tested and accepted by ZPMC Quality Control personnel. This QA Inspector generated an VT report for this date. The member(s) is/are identified as follows; Bike Path, on item number 1 of NWIT tracker document # 07877,

Unless otherwise noted, all work observed on this date appeared to generally comply with applicable contract documents.
